**Department of Public Works
Water Resources Engineering
212 South Bond Street
Bel Air, MD 21014
(410) 638-3545**

Water Resources Engineering

Sunnyview Stream Restoration
0 100 200 400 Feet

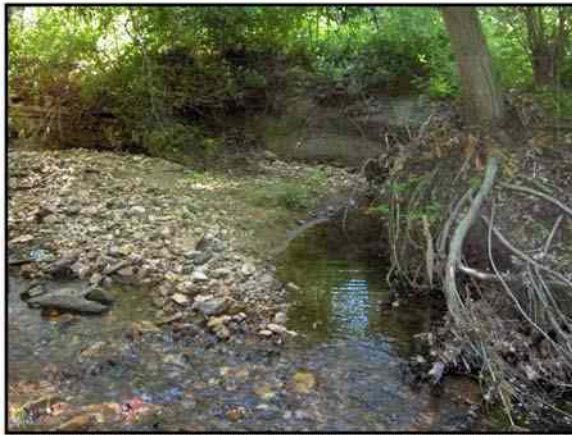
Photo 5 – View of bank erosion along the upstream right bank located just upstream of the downstream proposed work limits

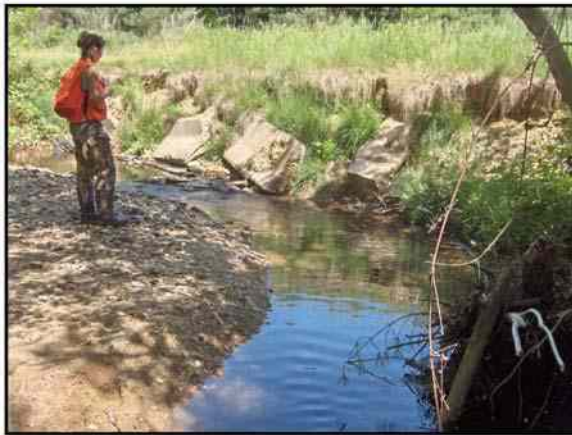
Photo 6 – View of concrete placed along the upstream right bank located just upstream of the downstream proposed work limits

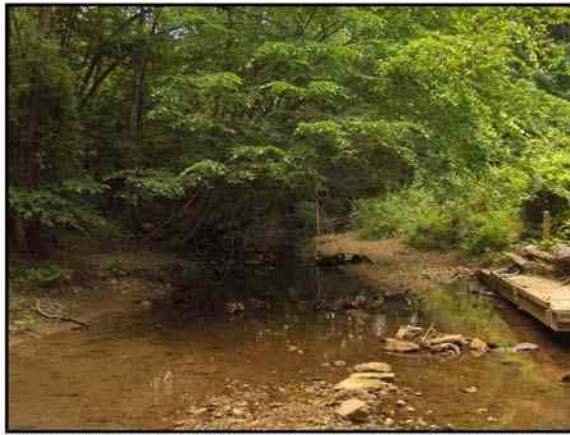
Photo 7 – Representative view (facing upstream) of an over-widened section within a wooded riparian zone

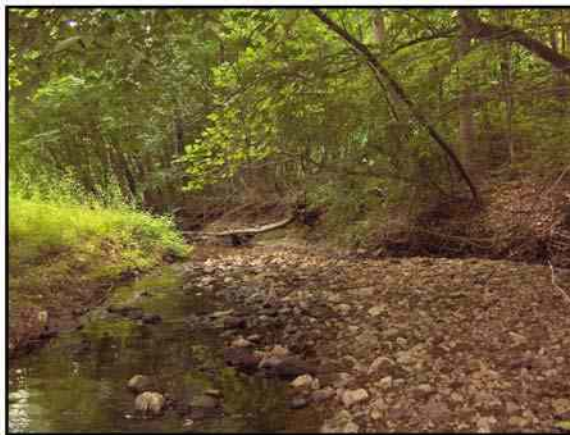
Photo 8 – Representative view (facing downstream) within a wooded riparian zone — note the sediment deposition

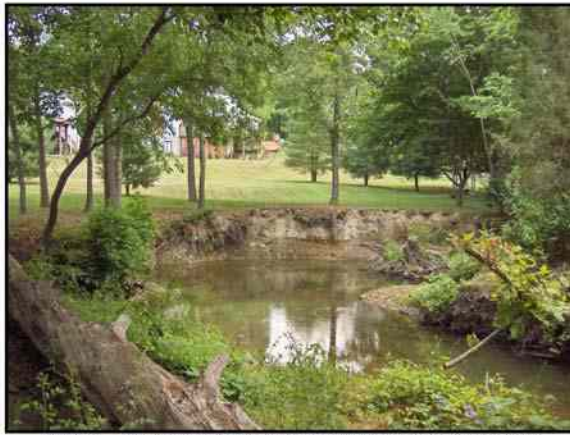
Photo 11 – Downstream view of bank erosion along a tight meander bend

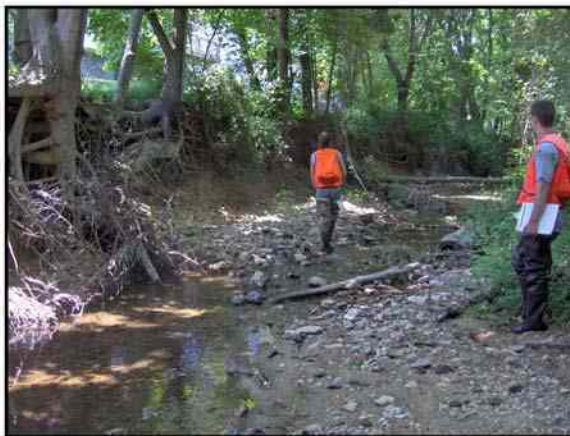
Photo 14 – Upstream view of bank erosion—note exposed roots

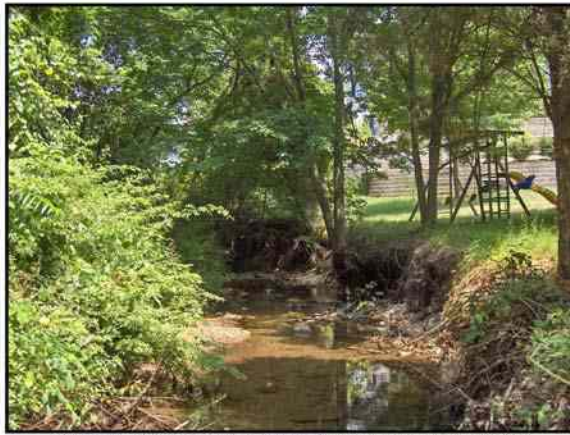
Photo 15 – Downstream view of bank erosion along a residential yard

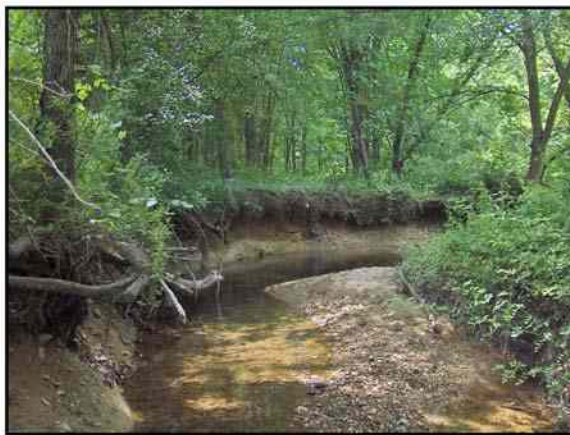
Photo 17 – Facing upstream toward bank erosion located just upstream of Option A of the upstream proposed work limits

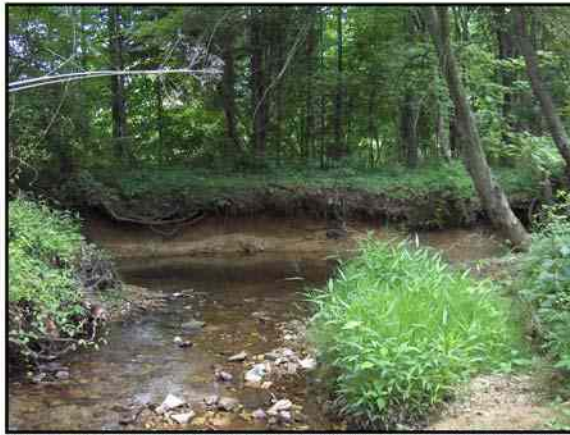
Photo 19 – Facing downstream toward bank erosion located just upstream of Option A of the upstream proposed work limits
